Manhole Inspection Summary

Manhole # S37G__037MH

Insp Date: **2/12/09 12:17 PM**

Location Address: **233 REDWOOD ST**

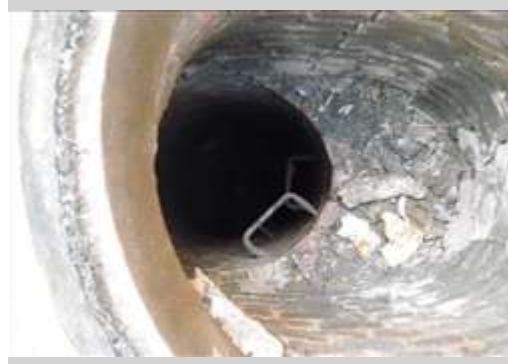
Top View

TOP VIEW FROM STREET LEVEL

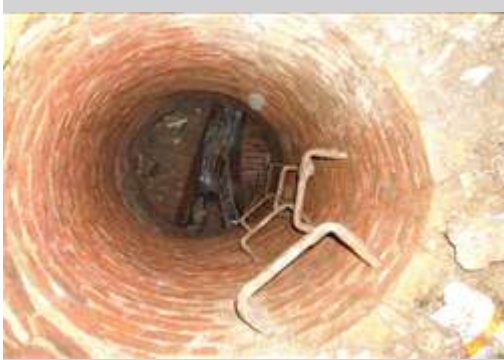
Miscellaneous

TOP VIEW FROM INSIDE CHIMNEY

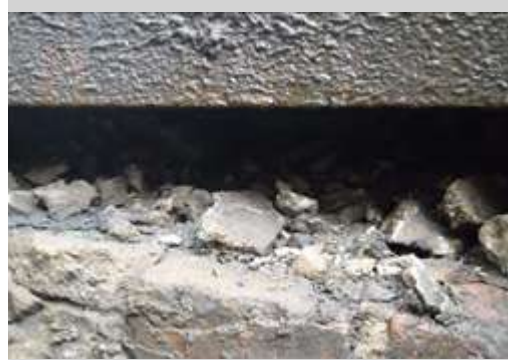
Defect 4

3" GAP BELOW FRAME

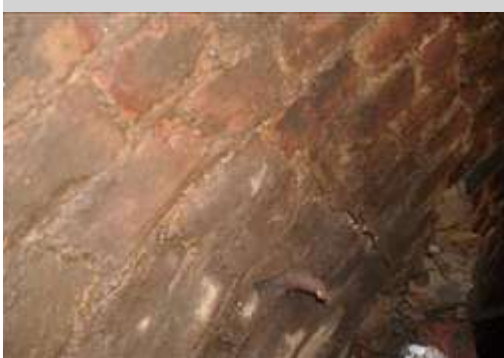
Defect 3

Condition: ☐ Sound ☒ Cracked ☐ Root Intrusion ☐ Loose Brick ☐ Deteriorated

Count: **9** Missing: **1** ☒ Corroded

STEP IN CHIMNEY IS MISSING/
CORRODED AWAY, CORBEL
CRACKED

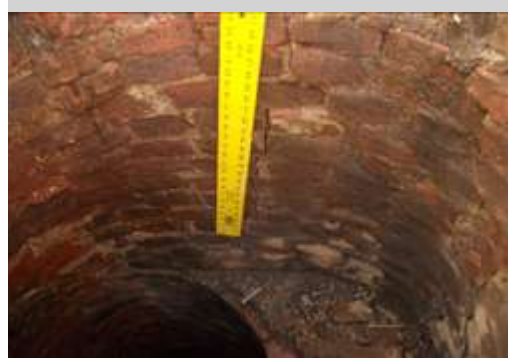
Defect 2

Condition: ☐ Sound ☐ Cracked ☐ Root Intrusion ☒ Loose Brick ☒ Deteriorated

CHIMNEY CRACKED BRICKS FROM
TOP TO BOTTOM ON BOTH SIDES

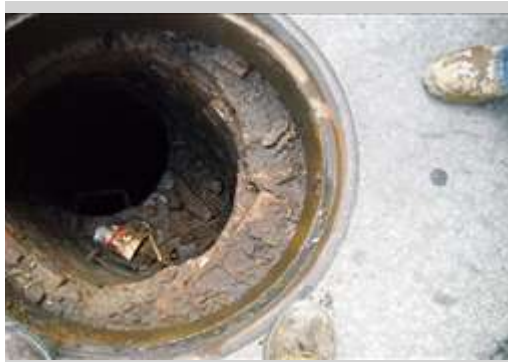
Defect 1

Offset: **6** (in.)

THE TOP IS OFFSET BY 6"

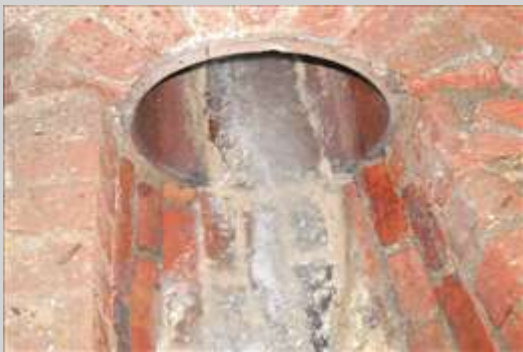
12 O'Clock Outflow

15 in. Circular Gravity Sewer
Pipe Out @ 12 O'Clock

Pipe Height: **15.6** (in.) Rod and Bar (Angled)
Pipe Material: **Clay** ☐ Pipe Lined
Invert Depth: **17.94** (ft.) Flow Characteristics: **Fast**
Deposits: ☒ None ☐ Mud ☐ Sludge ☐ Debris ☐ Grease
Silt Depth: **0** (in.) Deposits Extent:
Infiltration: **None** Pipe Seal Cond: **Sound**

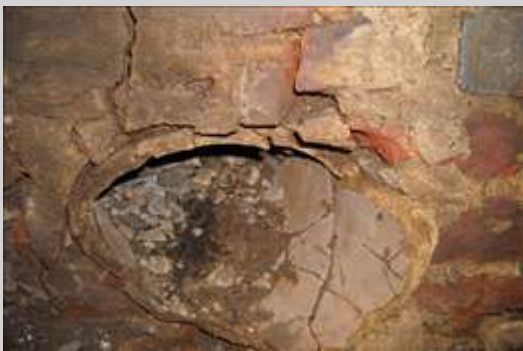
5 O'Clock Inflow

8 in. Circular Gravity Sewer
Pipe In @ 5 O'Clock

Pipe Height: **8.4** (in.) Rod and Bar (Angled)
Pipe Material: **Clay** ☐ Pipe Lined
Invert Depth: **3.87** (ft.) Flow Characteristics: **Slow**
Deposits: ☒ None ☐ Mud ☐ Sludge ☐ Debris ☐ Grease
Silt Depth: **0** (in.) Deposits Extent:
Infiltration: **None** Pipe Seal Cond: **Sound**

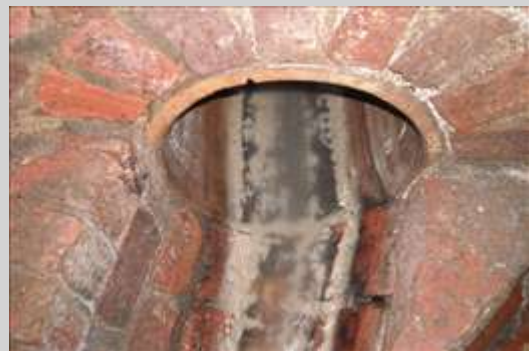
Drop In @ 5 O'Clock

Drop: **Inside** Rod and Bar
Angled: **Yes** Reading: **16.29** (ft.)
Inv Depth: **17.29** (ft.)
Drop Condition: **Open**

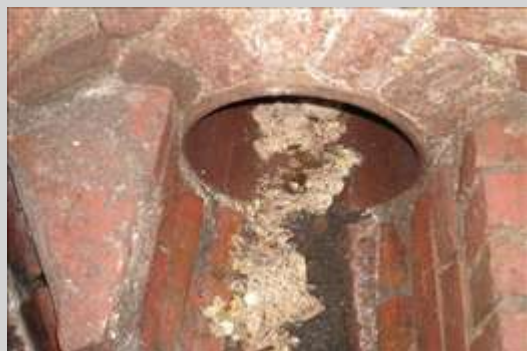
6 O'Clock Inflow

12 in. Circular Gravity Sewer
Pipe In @ 6 O'Clock

Pipe Height: **12** (in.) Rod and Bar (Angled)

Infiltration: **None** Pipe Seal Cond: **Sound**
